Massachusetts Department of Environmental Protection
Bureau of Resource Protection – Watershed Permitting Program
Sanitary Sewer Overflow (SSO)/Bypass
Notification Form

Hull WPCF
Reporting Sewer Authority

Location: 14 VAUTRINT AVE
(Description of discharge site or closest address)

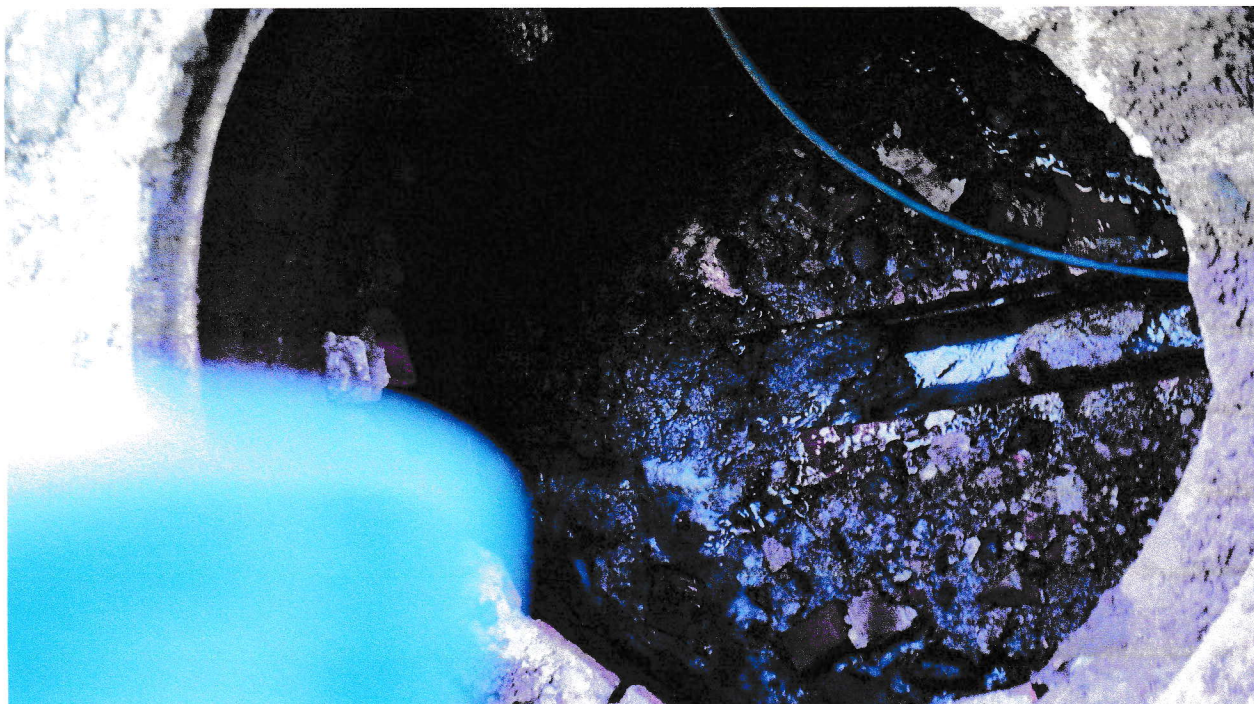
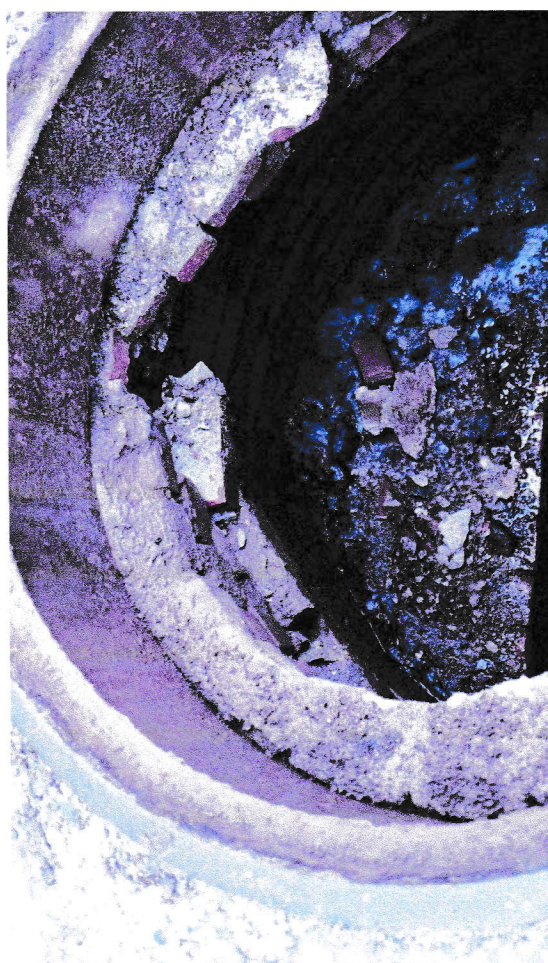
IN conclusion; leak caused by brick in SEWER main. SEWAGE BACKED UP + WAS leaking out of a clay pipe joint.

Service: Inspect manholes and camera used. Could not snake through from upstream manhole. Got to within 25 feet of leak snaking camera upstream. Upstream manhole of leak had a lot of debris and evidence of manhole deterioration. Report findings to PSC.

SEWER MAIN REPAIR FOR uniform 6" piping.
